## Home Inspection Report

**Inspection Location: 1234 Spring Garden Road**

**Halifax, NS B4M 1F8**

**Date of Inspection: 02-30-2013**

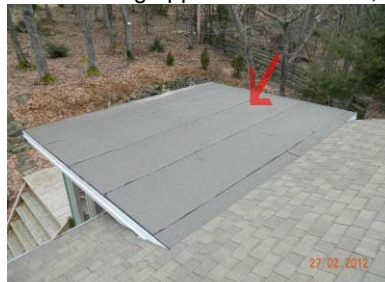
roof covering appears serviceable, no leaks detected at the time of the inspection.

**roof covering appears serviceable**

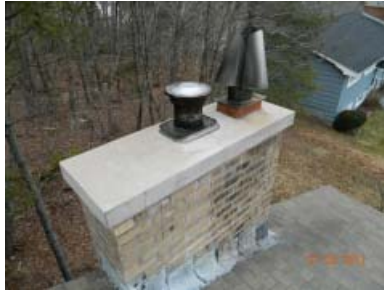
flue appears serviceable.  
one, brick.  
chimney appears serviceable.  
chimney installation appears to meet clearance requirements.

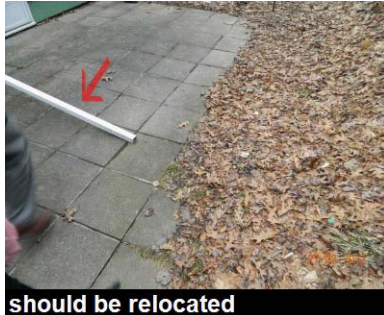
metal.  
eavestrough & downspouts appear serviceable, downspout located on the back of the dwelling should be relocated.

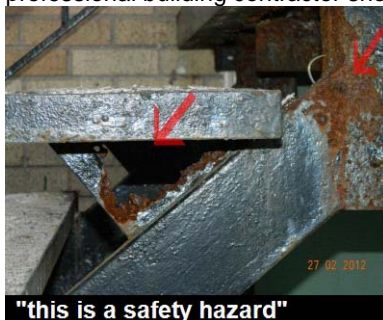
Location: front of dwelling.  
Type: steel.  
Condition Of Steps & Landings: major repairs required or re-build steps and landing, large areas of rust noted, "this is a safety hazard" spalling or chipping noted in concrete on stairs and landing, a professional building contractor should be called to make further evaluation.

"this is a safety hazard"

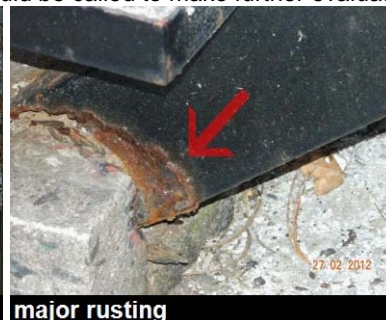
major rusting

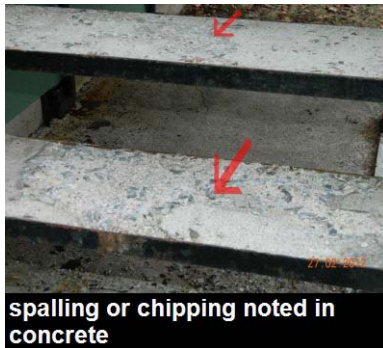
**spalling or chipping noted in concrete**

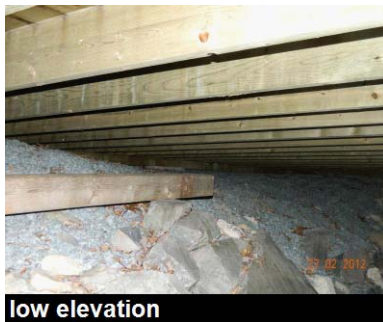
back of dwelling.  
wood.  
deck appears serviceable, low elevation of deck prevents full viewing under the structure. Additional lot grading improvements are required along the side to provide proper drainage.

**low elevation**

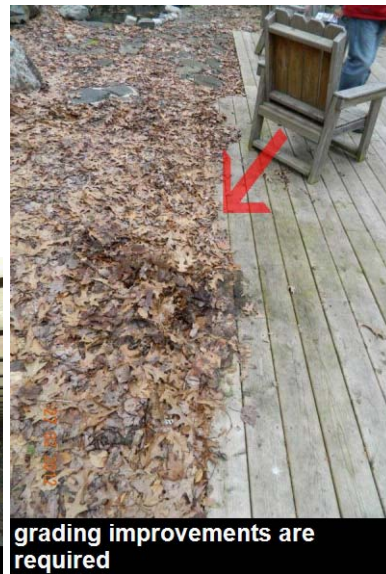
**grading improvements are required**

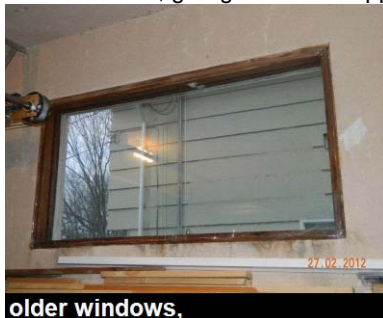
*Interior Garage Window Frame:* wood.  
*Garage Window Style:* sliding.  
*Condition Of Garage Windows:* older windows, garage windows appear serviceable.

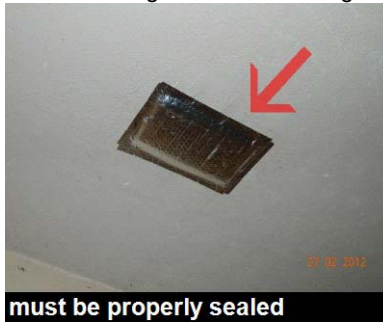
*Condition Of Garage Heating:* hot air heating vents located in garage ceiling must be properly sealed.

**must be properly sealed**

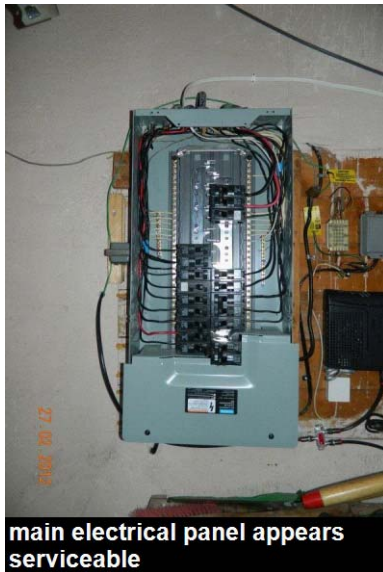
main electrical panel appears serviceable

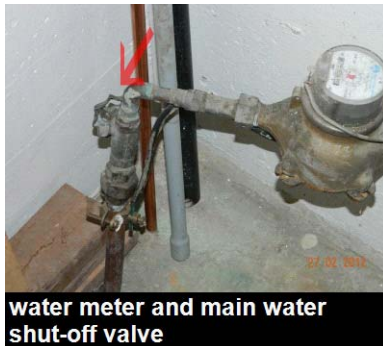
water meter and main water shut-off valve are located; along the front wall;

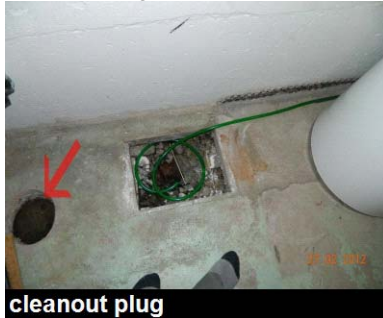
*Location Of Waste Drain Cleanouts:* cleanout plug was noted in the floor of the; basement.

**cleanout plug**

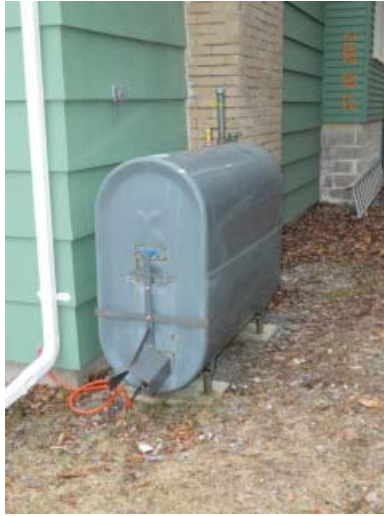
oil line & valve appear serviceable, there is a loop in the oil line.

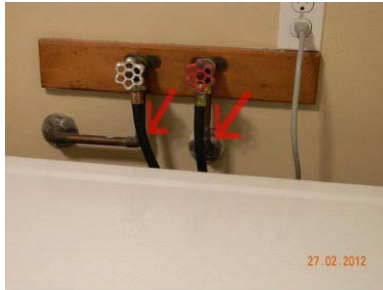
Plumbing appears serviceable, Washer was not operated at the time of inspection. New braided stainless steel fill hoses should be installed.

**add braided stainless steel fill hoses**

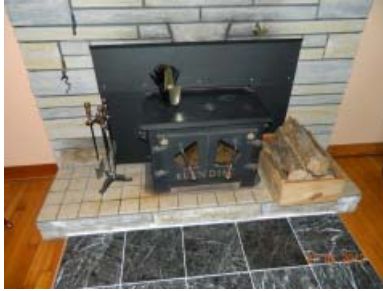
wood stove insert certification could not be found, The fireplace insert should not be used until a professional WETT installer certifies it.

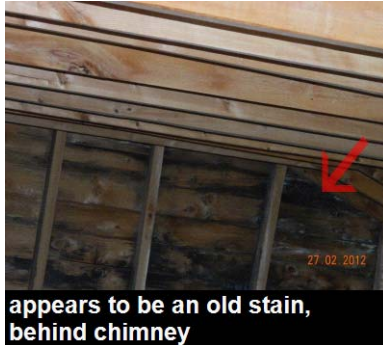
attic sheathing appears serviceable; the rafters or truss system appears to be in satisfactory condition, staining on the decking behind the chimney appears to be an old stain.

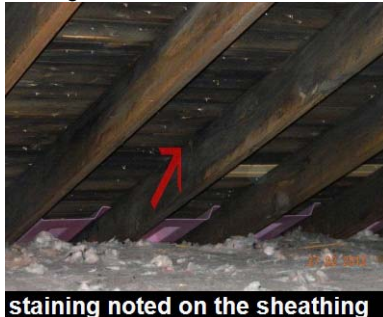
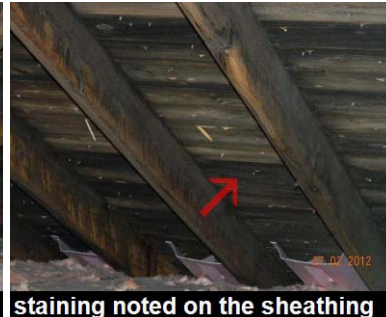
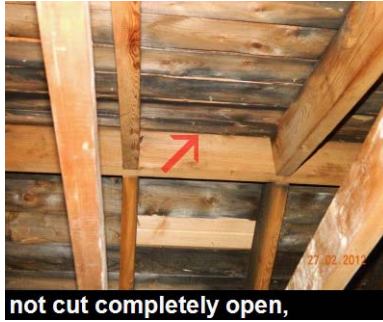
staining noted on the sheathing, this is caused by a lack of proper ventilation, ridge venting is not properly installed; sheathing not cut completely open, a professional roofing contractor should be called to make further evaluation.

**not cut completely open,**

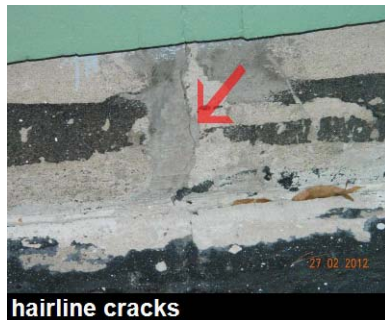
There are two hairline cracks in the foundation walls. These cracks should be filled with a silicon base, flexible-sealing compound, which should stop water/moisture from penetrating. At the time of the inspection no signs of water or water penetration were found.

hairline cracks

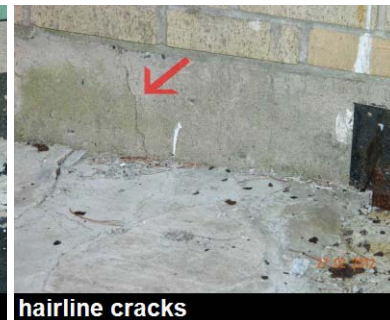
hairline cracks

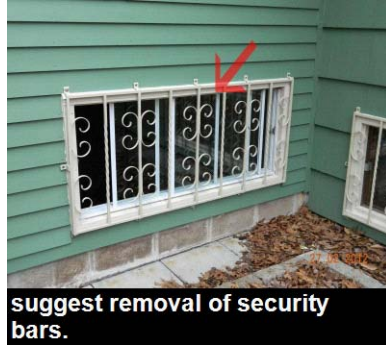
older windows, suggest removal of security bars.

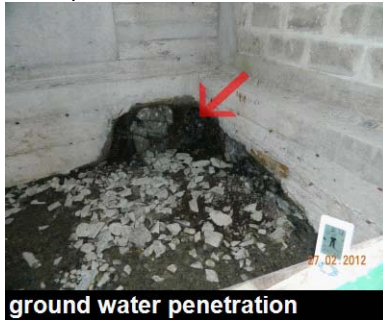
Evidence of moisture in crawl space indicates that the area has experienced ground water penetration, monitor this area.

**ground water penetration**
